Release Notes for PCS-G70 & G50 - V2.64 Software

Release version 2.64 has been issued as mass production units from November have hardware change, related drivers and components have been changed to accommodate the new disc on chip hardware change.

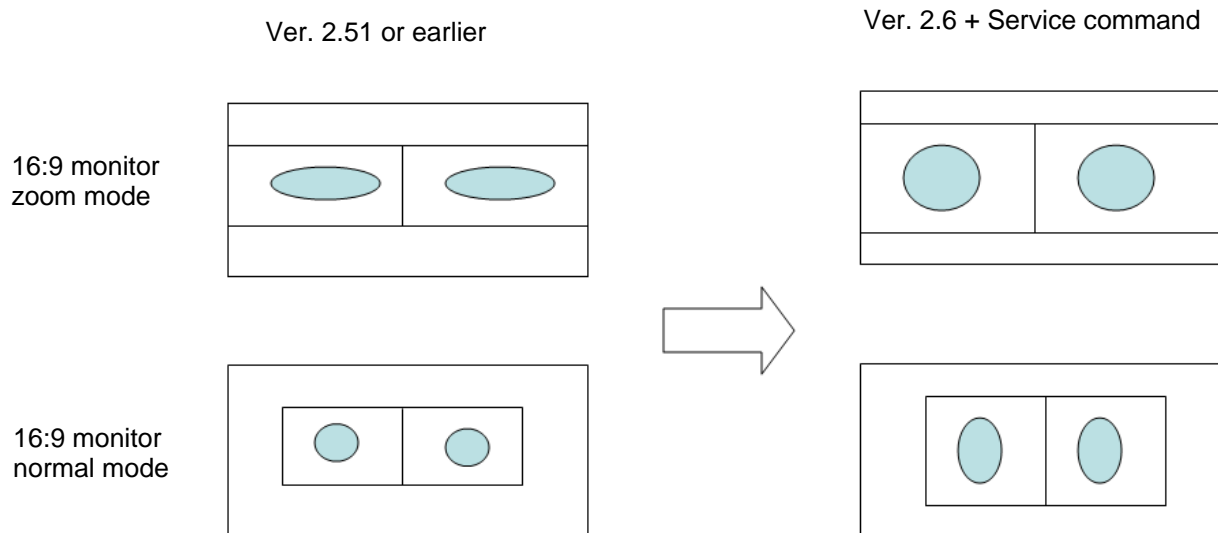
When a 16:9 format monitor was connected to the VIDEO OUT and monitor mode was set to "Full", 4:3 format images were stretched into 16:9 format display for all of the conventional modes. In Side By Side or Picture and Picture mode, a large amount of area above and below the image did not display anything. With this service command, the image reduces the amount of black area on the top and bottom of the display

- The launcher menu, full screen, camera menu, and other image displays are still stretched.
- When this mode is used, the terminal name display is displayed at the shifting position.
 - Please disable to terminal name display.
